"Full" Reserve Study

Kings Row HOA Carbondale, CO

Report #: 16151-1 For Period Beginning: January 1, 2015 Expires: December 31, 2015

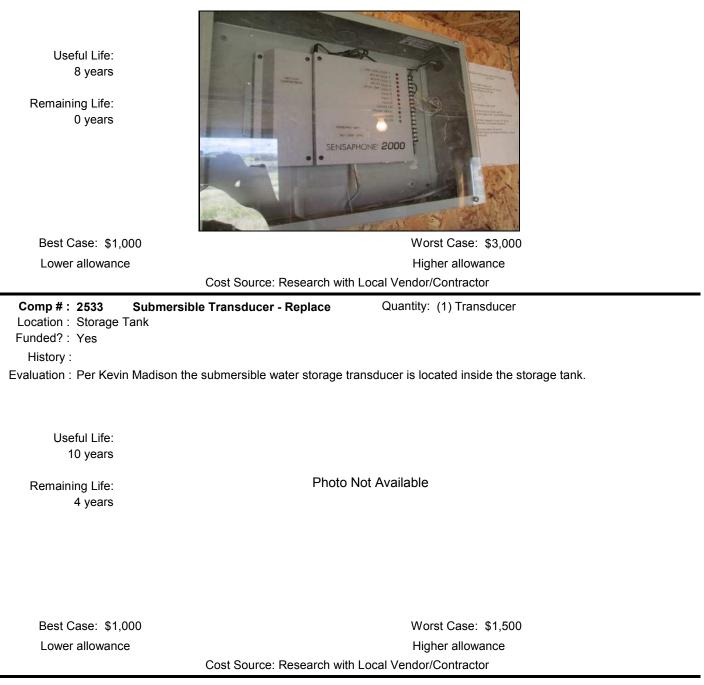
Comp # : 2531	Sensaphone - Replace
	eeneaphene nephaee

Evaluation : Per Kevin Madison - 970/618-5680, the current unit is obsolete and should be replaced soon.
